IGS09-03 LP Turbine Last Stage Bucket Replacement Proposals Evaluation

IGS LP TURBINE LAST STAGE BUCKET REPLACEMENT

IPP, Unit 2 LSB Erosion (270T151)

TO: George Cross
FROM: Wes Bloomfield
DATE: June 12, 2008
SUBJECT: Recommendation to replace low pressure turbine last stage buckets

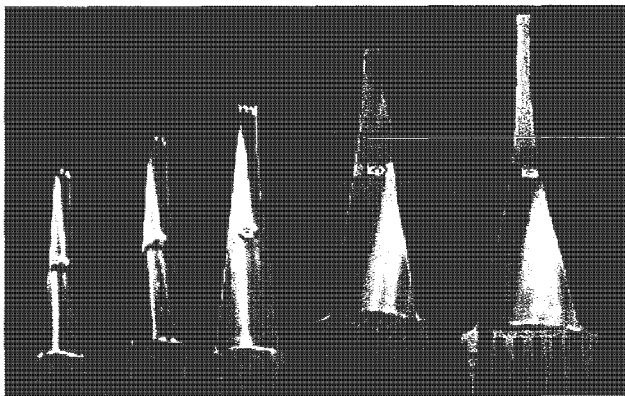
Figure 1: L-0 Self Shielded Jethete Buckets

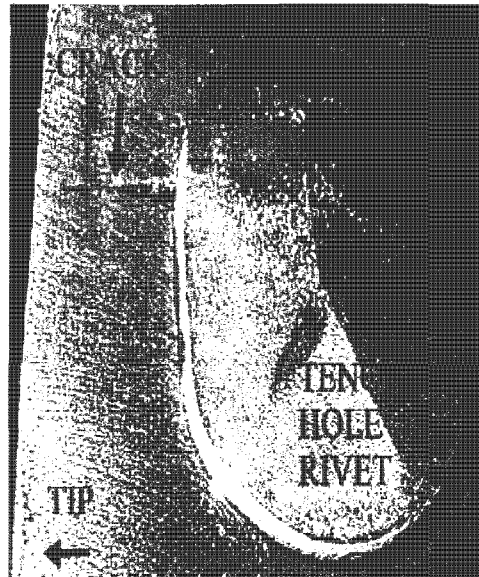
The 33.5" buckets in general have had a good fleet reputation except for cracks that occur at the tip of the buckets. Each bucket has a riveted spacer block that acts to continuous-couple the buckets at speed. It is not uncommon for cracks to start in the tenon hole and propagate to the tip of the blade. However PacifiCorp is unaware of any instances where tenon-hole cracks have resulted in a significant in-service blade failure. Note the Dave Johnston Unit 4 LP LSB tenon-hole crack indication, from April 2005.

It has been GE's recommended practice that buckets with the tenon cracks be replaced rather than weld-repaired. It was demonstrated in 2003 at the Dave Johnston Station that these tenon-hole cracks could be successfully weld repaired and post-weld heat-treated without removing the buckets from the rotor. Over the past 25 years, self-shielded Jethete M152 buckets have replaced the ones with cracks at tenon holes. This resulted in a mixture of bucket types in rows that previously had only stellite-shielded buckets.

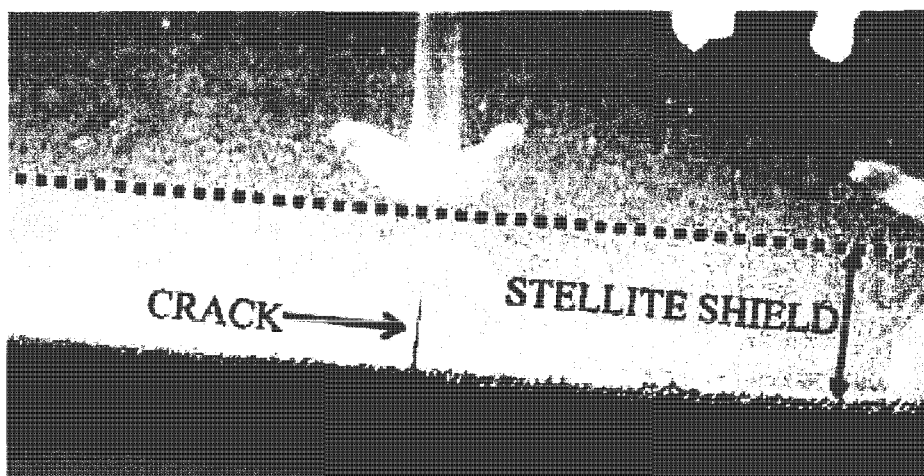
In the stellite-shielded buckets (both 422 SS and Jethete) fatigue cracks that develop in the stellite shield zone of the blade generally do not propagate beyond the Inconel barrier of the attachment weld and can be removed by buffing or light grinding. See above the figure of a leading edge crack in the satellite shield of a Dave Johnston Unit 4 bucket.

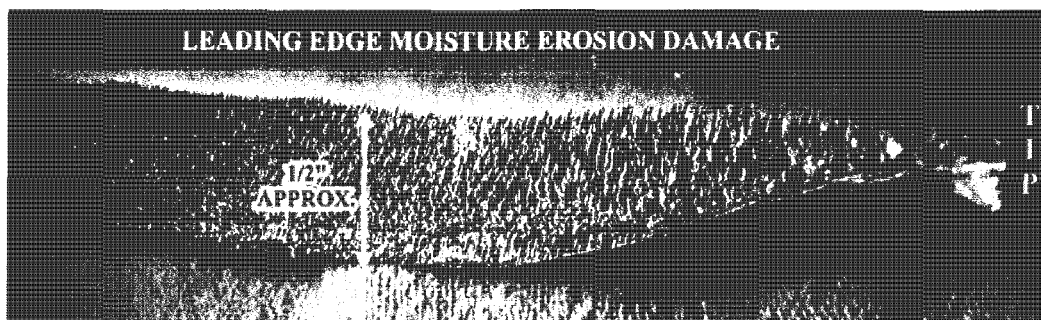
Ameren owns and operates the Coffeen Power Station in Coffeen, Illinois. The 590 MW Coffeen Unit 2 is a swing-load unit that operates in a range of 40-100% rated load. It has a cyclone sub-critical once-through boiler that makes it difficult to maintain reheat temperature at lower loads. Backpressure is typically below 3" Hg, but there are brief excursions in the summer to 3.5" Hg. The GE Model G2 steam turbine has two double flow low-pressure turbines with 30" last stage buckets. The unit was placed in commercial service in 1972 and operated for 22 years before the last stage buckets were replaced in 1993 because of tie wire cracking. Heavy erosion of the satellite-shielded buckets was also observed. The replacement buckets were the GE Jethete M152 'self-shielded' buckets, and experienced heavy moisture erosion along the leading edge. The erosion wastage created crevices along the leading edge, with the deepest crevices near the tip of the buckets.

In March of 2004, when the replacement buckets were approximately ~~nine years~~ old, the first in-service failure of these buckets occurred. While the unit was in operation, the tip of a bucket liberated and necessitated a two-week outage for repairs and replacement of several buckets. An analysis of the failed bucket disclosed that a crack had initiated in a moisture-erosion crevice approximately 1/2" from the original nose of the bucket, near the tip where the deepest erosion crevices existed. The ~~crevice~~ notch served as an initiation site for a high-cycle fatigue crack.

After the failure, the last stage buckets were inspected, the damaged buckets were replaced, and attempts were made to eliminate the worst of the foreign object damage along the bucket leading edges near the tip of the buckets by grinding and contouring the erosion areas. The unit was returned to service with the intent of operating it until a scheduled dismantled inspection in February 2005.
